Sizing Up A Seismic Retrofit

Upgrades restore functionality to building once condemned as dangerous

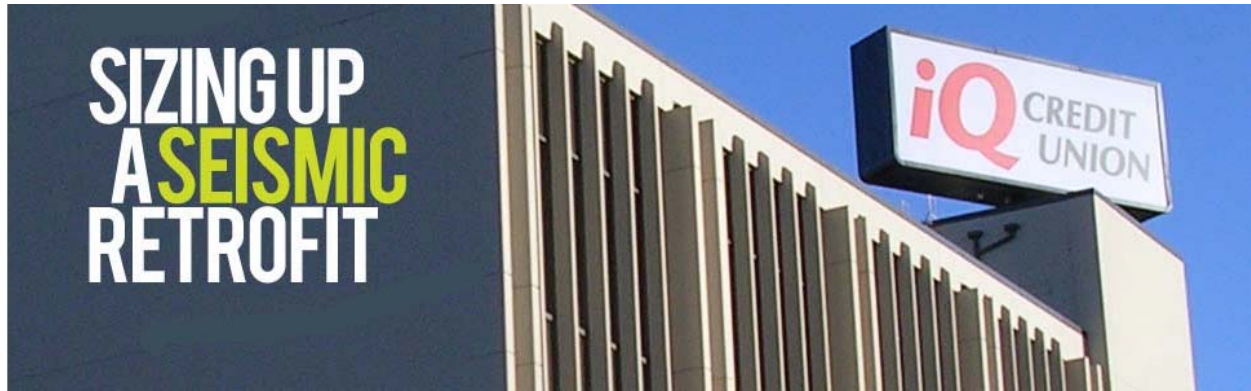
The C-shaped columns depicted above bore the gravitational load of the building but were found to be structurally deficient because their shape rendered them non-ductile.

The building was classified as a “dangerous building” because of two main seismic deficiencies: the non-ductile columns that if failed during a seismic event would cause a loss of gravity support for the floors and a lack of adequate diaphragm connection to the shear walls.

Options for mitigating the seismic deficiencies were developed and studied. Mitigation options for the non-ductile concrete columns consisted of either adding columns to the building to support floor loads if the existing columns were to fail during a seismic event, or confining the existing concrete in the columns by filling in the open C-shape of the column with reinforced concrete and then wrapping the columns with fiber reinforced polymer (FRP). Because of the useable floor space that would be lost by the addition of columns, the FRP wrap was chosen as the preferred option.

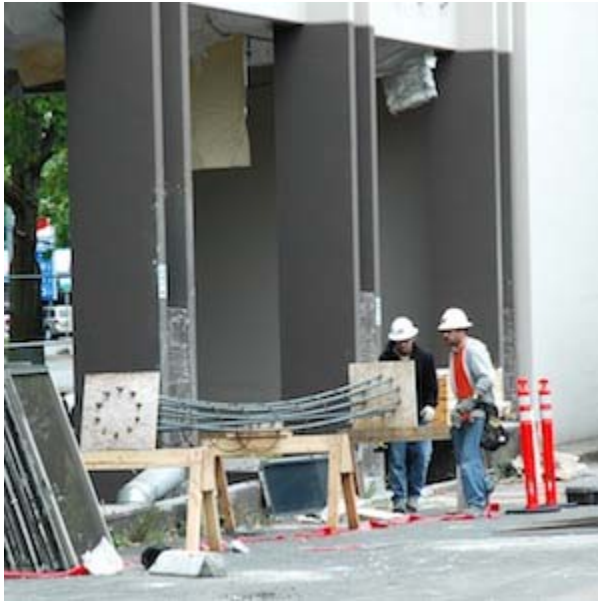
Workers prepare to reinforce non-ductile columns.

Because the design and the application of FRP is a specialty sub-contract, the requirements for the FRP column wrap was specified to be equivalent to a reinforcing steel column spiral of a certain size and pitch and designated as “bidder-designed.” The FRP shop drawings were accompanied by fully engineered calculations that verified the capacity of the FRP to perform equivalent to the specified spiral reinforcement.

The FRP seismic retrofit work was executed by a subcontractor with its propriety system. This entity received design performance parameters and details from the structural engineer, architectural constraints from the architect, as well as the constraints presented by the existing facility. Their scope included demolition to expose the area of work, scaffolding, column surface and corner preparation work and the installation of the FRP wrap. The column rebar reinforcing system and concrete in-fill placement were performed by the general contractor, as was the final column cladding once the FRP installation was complete.
